Injury during mooring operation

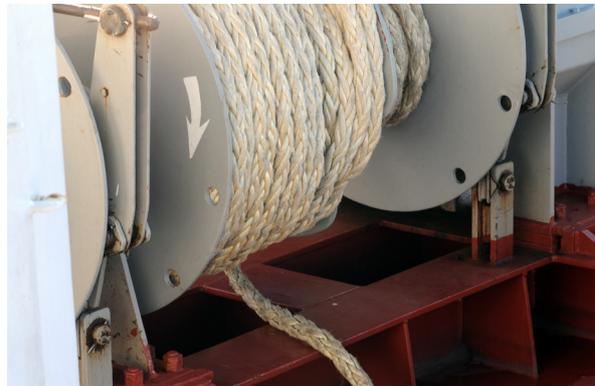
Suddenly the 3rd Officer started to scream. The AB turned around and could see the 3rd Officer was caught between the mooring line and the fairlead. The mooring line was now coming out very quickly and was cutting into the 3rd Officer's leg.

The mooring line's speed was now so fast that it cut through the officer's clothes and he was bleeding badly. The mooring line was actually cutting through the 3rd Officer's leg and it was cut off just below the knee.

The Chief Officer realized that the mooring rope was stuck in the propeller and screamed over the VHF to the Master to stop the engine. The master pushed the emergency stop and the propeller stopped.

- The vessel had a risk assessment for the mooring operation, but it didn't include the risk of the mooring line getting stuck in the propeller, as the mooring line should be floating in normal circumstances. This time the mooring line was lowered too quickly and ended up under the surface. The propeller blades are only 2 meters below the surface so the lines were sucked into the propeller, which caused the accident.

- Another risk was that the mooring line was partly around the bollard, with a bight and a right angle to the normal pull direction. This arrangement caused the snapback zone to cover the entire area between the bollard and railing. When the rope ran out rapidly and got caught in the propeller it snapped back to where the 3rd Officer was standing. The Officer was actually not inside the normal snapback zone. This shows the importance of everybody involved in the operation to be aware of the risks of potential snap back zones. Mooring a vessel is a normal operation, but the risks need to be evaluated every time, as it is a risk operation.
