# National Transportation Safety Board

## Marine Accident Brief

### Grounding of Mobile Offshore Drilling Unit *Kulluk*

<b>Accident no.</b>	DCA13NM012
<b>Accident type</b>	Grounding
<b>Vessel</b>	Mobile offshore drilling unit <i>Kulluk</i>
<b>Location</b>	Near Ocean Bay, Sitkalidak Island, Alaska
<b>Date, time</b>	December 31, 2012 2040 Alaska standard time (coordinated universal time – 9 hours)
<b>Damage</b>	Substantial
<b>Injuries</b>	Four minor
<b>Environmental damage</b>	None
<b>Weather and sea conditions</b>	At departure, moderate winds and seas with scattered precipitation, expected to continue during first days of voyage; several days later, low pressure moved into Gulf of Alaska area. By December 31, recorded winds reached 40–55 knots, with seas more than 20 feet.
<b>Waterway information</b>	Gulf of Alaska lies south of the state of Alaska in the northern Pacific Ocean

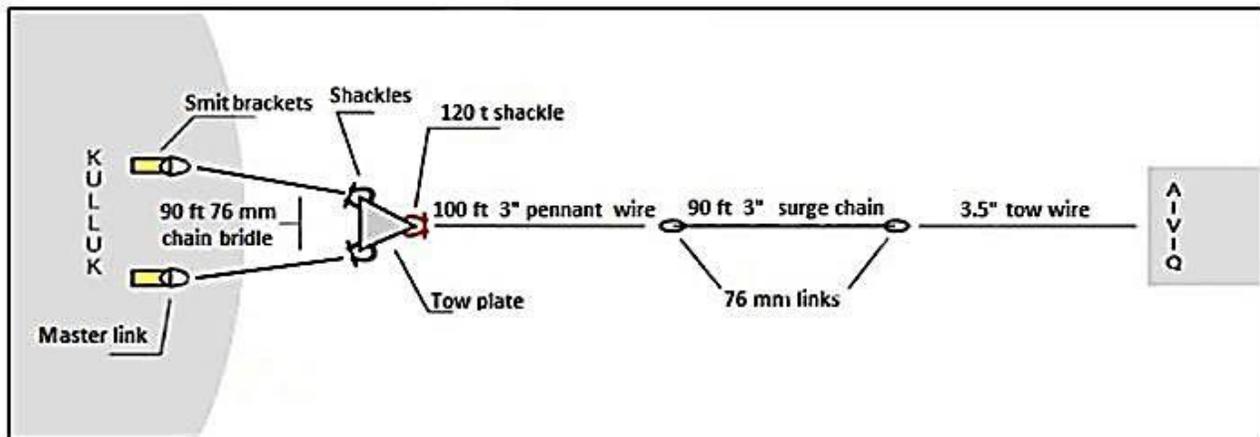
No regulations or class rules govern the demonstrated strength, useful life, number of cycles, or repeated stresses to which the tow line and tow gear could be subject, although the IMO has established guidelines and several countries have promulgated regulations to that effect. Shell testimony and documentation provided to the Coast Guard hearing demonstrated that the company followed industry practices with regard to manufacture, use, and inspection of the tow gear, and as noted, the warranty surveyor visually inspected the tow gear. The *Aiviq*'s towing gear consisted only of a 3.5-inch tow wire connected to the *Kulluk*'s gear with a segment of surge chain followed by the towing pennant. This pennant was connected to shackles and then to the towing plate. Shackles connected the towing plate to chain bridles, which were secured on the *Kulluk* with Smit brackets.<sup>5</sup>

Configuration of *Kulluk* and *Aiviq* tow gear. (Drawing adapted from Coast Guard)

The broken component of the *Kulluk*'s tow gear, a 120-ton shackle that was connecting the towing plate to the 100-foot-long, 3-inch pennant, was lost at sea during the initial December 27 tow gear separation, and investigators were unable to determine the cause of its failure.

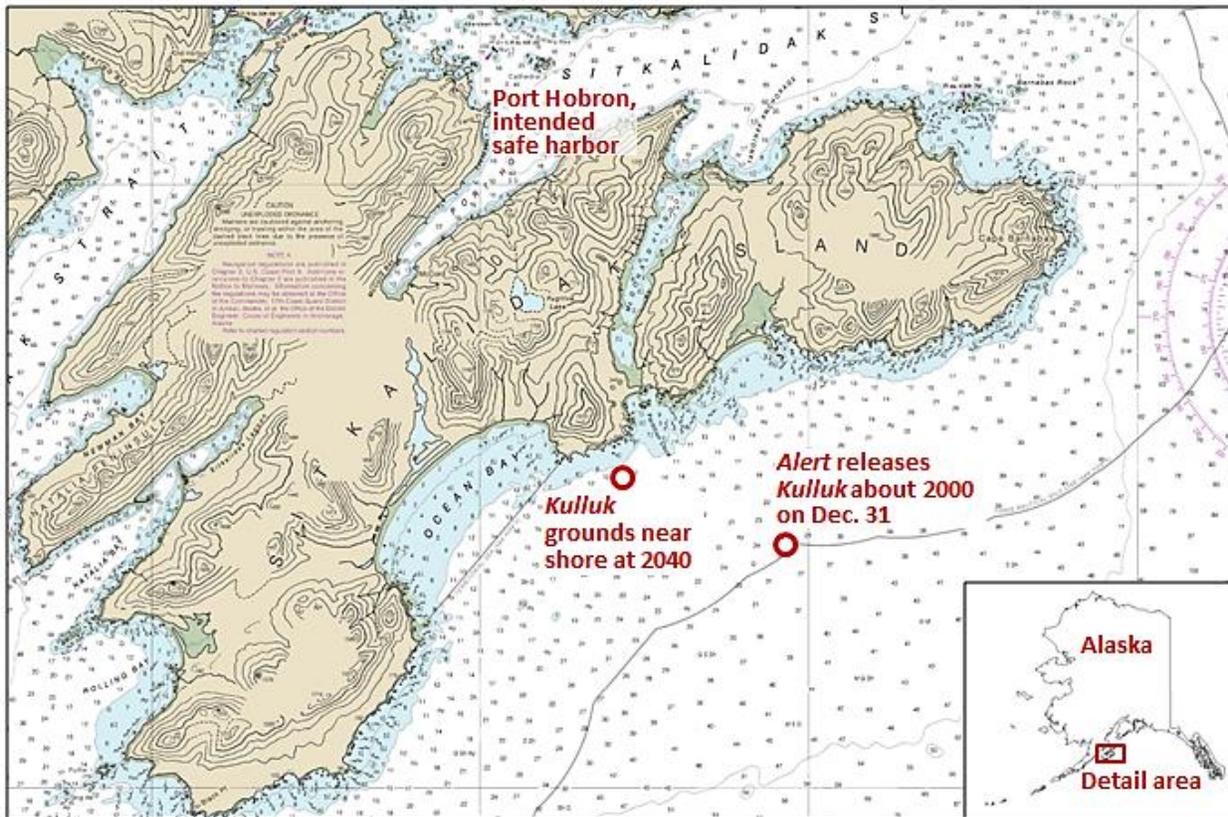
conditions continued to worsen, and with winds as high as 55–60 knots and seas 30–35 feet, the *Alert*, with the *Kulluk* in tow, continued to be pulled toward shore. At 1815, the master of the *Alert* ordered that the engines be set at 100 percent power. They were brought back to 85 percent power at 1835 due to the alerting of engine alarms at the 100 percent setting. When the vessels were 3 miles from shore, the unified command ordered the *Alert* master to release the tow, and the *Kulluk* grounded off Ocean Bay, Alaska.

Vessel positions when the *Alert* released the *Kulluk* and location of the *Kulluk* grounding about 40 minutes later on December 31, 2012, near Ocean Bay, Sitkalidak Island, Alaska. (Excerpt from NOAA chart 16592)

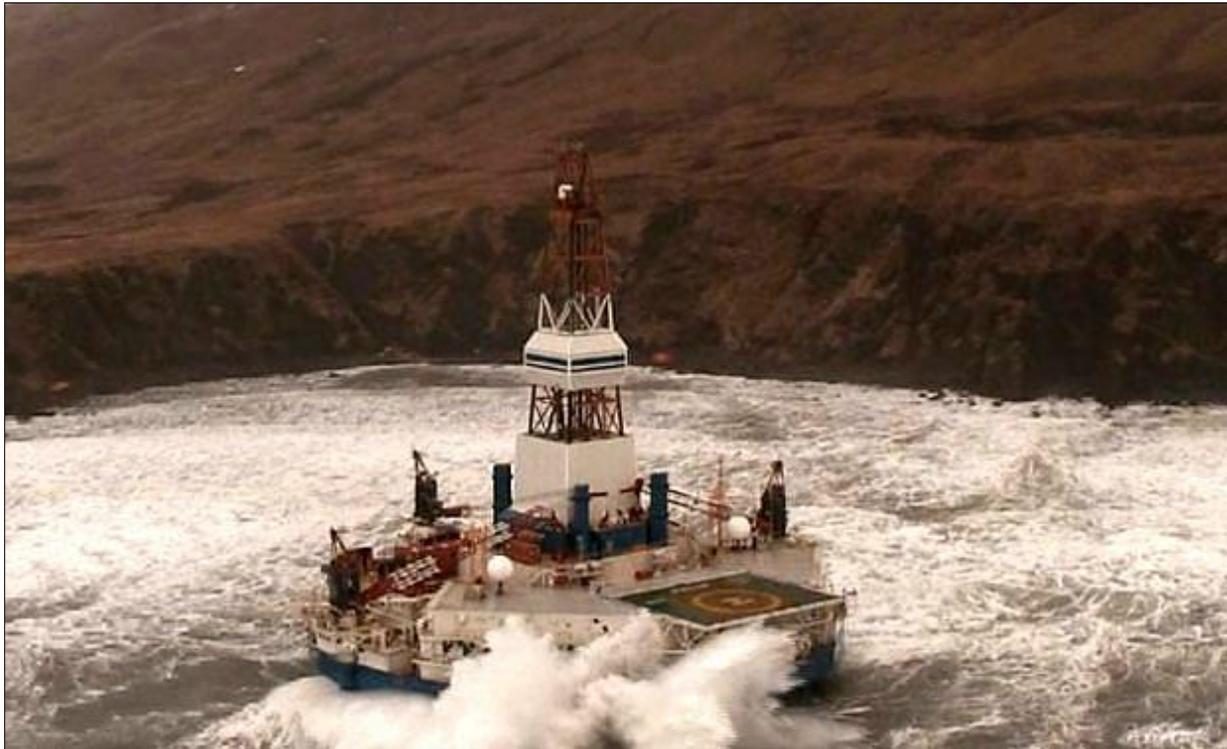
The MODU sustained substantial damage. A postaccident inspection conducted by a third party before the vessel was refloated found underwater portions of the hull were extensively damaged although it retained watertight integrity. Widespread damage also was noted to areas including the vessel’s superstructure, electrical equipment, lifesaving and safety equipment, and interior and engineering spaces.

MODU *Kulluk* aground off Ocean Bay, Sitkalidak Island, Alaska. (Photo by Coast Guard)
