National Transportation Safety Board

Marine Accident Brief

Fire Aboard Containership *Gunde Maersk*

Accident no.	DCA16FM009
Vessel name	<i>Gunde Maersk</i>
Accident type	Fire
Location	Seattle, Washington
Date	December 8, 2015
Time	0509 Pacific standard time (coordinated universal time – 8 hours)
Injuries	None
Property damage	\$380,000
Environmental damage	None
Weather	Light rain, visibility 4 miles, ¹ winds south-southeast at 8.1 mph, air temperature 52°F
Waterway information	Elliott Bay, also known as the Port of Seattle, is a deep water port within Puget Sound

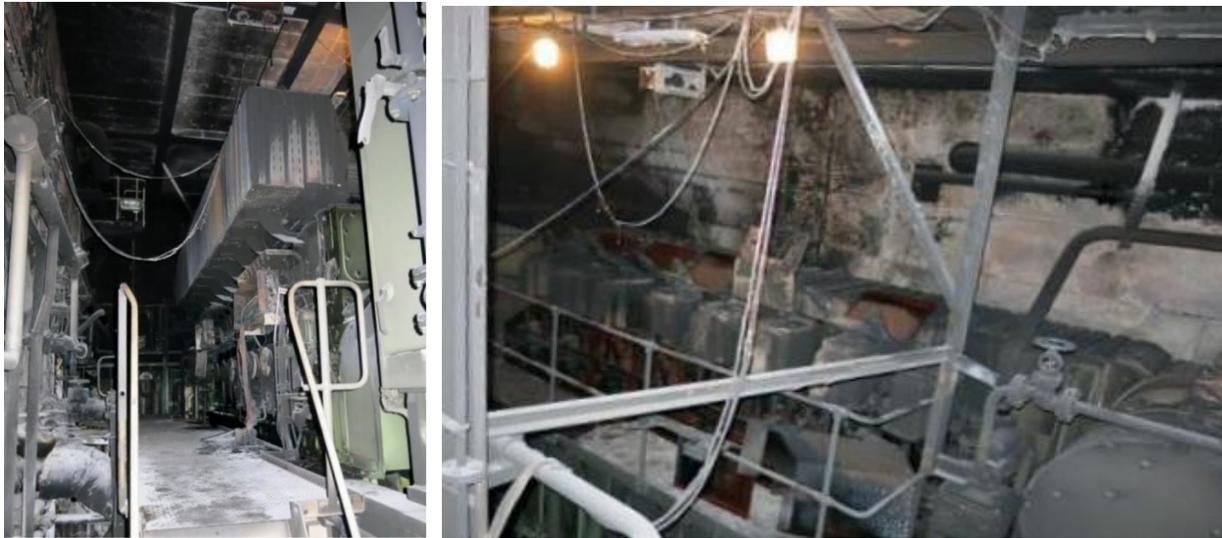
Fire damage to auxiliary engine no. 1. Left photo shows inboard side, looking forward; right photo shows the outboard side, looking aft. (Photos courtesy of Lavaretus Risk Engineering)

The source of ignition was most likely fuel spraying and flowing onto the exhaust side of the engine between the cylinder covers. The exact time the leak began could not be determined, but it continued for a long-enough period to fill the overflow tank before the fire started. The fuel overflow tank alarm activated 13 seconds before the fire alarm sounded.

The exact point of ignition also could not be determined. However, the exhaust piping, which is estimated to have been between 575 and 850 degrees F at the time of the fire, was the most likely location.

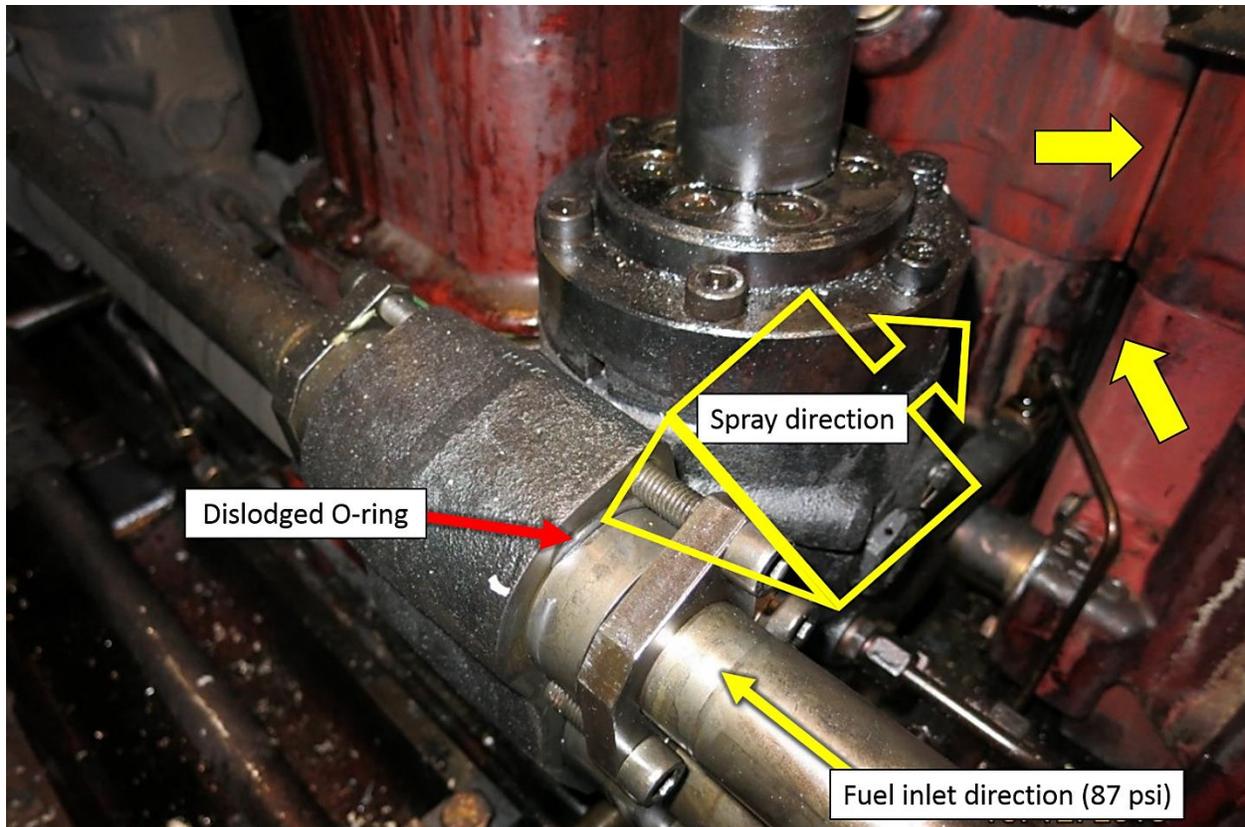
Investigators determined that the fire was caused by fuel leaking from a dislodged 1.5-inch-diameter O-ring in the fuel supply line to the no. 3 cylinder fuel injection pump, located near the top of auxiliary engine no. 1. Fuel in the supply line, pressurized to 87 pounds per square inch (psi), sprayed out around the O-ring. Some of the spray struck shields designed to prevent atomized fuel from spraying the engine room, while the remainder of the spray entered the exhaust side of the engine through the space between the cylinder heads. The fuel that struck the spray shields dripped into a fuel drain channel that ran the length of the engine under the fuel supply pipe. The fuel then drained into the 5-liter-capacity overflow tank until the tank was filled, sounding the tank overflow alarm.

Investigators found that the bolts and fitting where the leak occurred were in good condition. The NTSB performed a microscopic examination of the O-ring, and no damage or imperfections were found. It is likely that the leak occurred because the fitting was not tightened with a torque wrench as prescribed in the manufacturer's written procedures.

Location of fuel leak on Auxiliary Engine No. 1 fuel injection pump #3 (Photo courtesy of Lavaretus Risk Engineering)

The National Transportation Safety Board determines that the probable cause of the fire aboard the containership *Gunde Maersk* was an improperly installed fitting on a fuel line supplying a fuel injector pump for auxiliary engine no. 1.

Additionally, a root cause report issued by the operating company after the accident noted that procedures to replace O-rings on auxiliary engines did not include a post-repair testing procedure. Had the fuel system been tested using a standard procedure under normal operating conditions, it is possible that the leak would have been found before the fire started.

The NTSB continues to see fires and other accidents caused by failure to adhere to standardized procedures during the maintenance, repair, and testing of equipment. Standardized procedures, which include the use of proper tools, ensure system integrity and the safe operation of equipment within designed specifications. This simple guidance bears repeating, because the consequences of failure—\$380,000 in damage to the *Gunde Maersk* alone—can be significant.

Post-repair and maintenance operational testing of equipment should be standardized and, where possible, conducted at normal operational pressures and loads to verify the quality and reliability of the maintenance conducted.
