Casualty Investigation
Report No. CA118

**Isle of Man Registered “Sharp Lady”
Enclosed Space Fatality and Near Fatality**

23rd August 2013

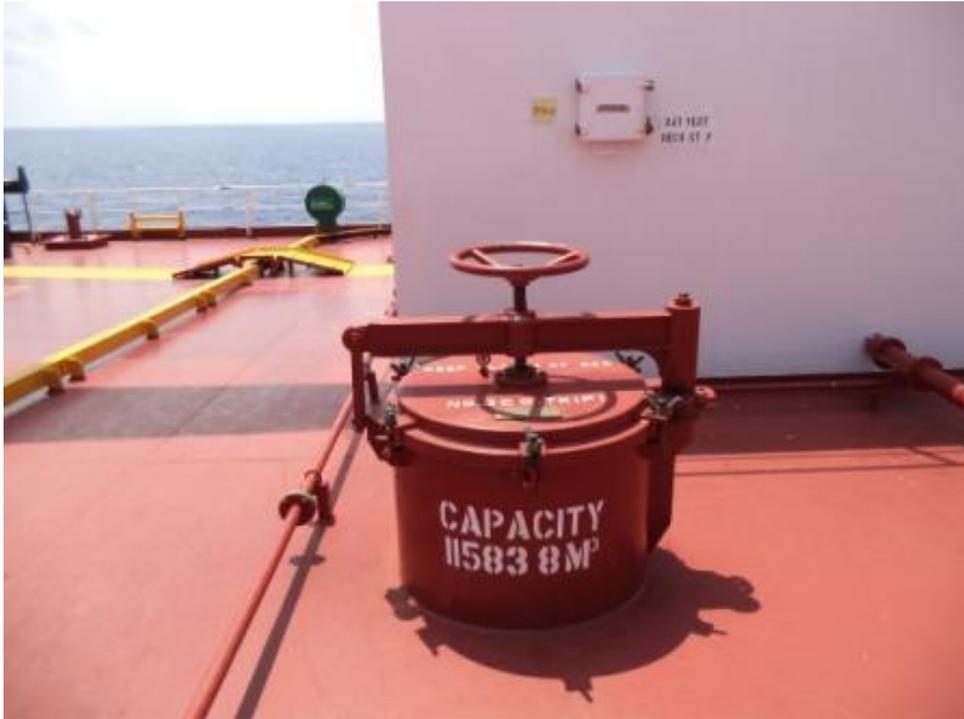
Sharp Lady – 3P Cargo Oil Tank – tank access hatch

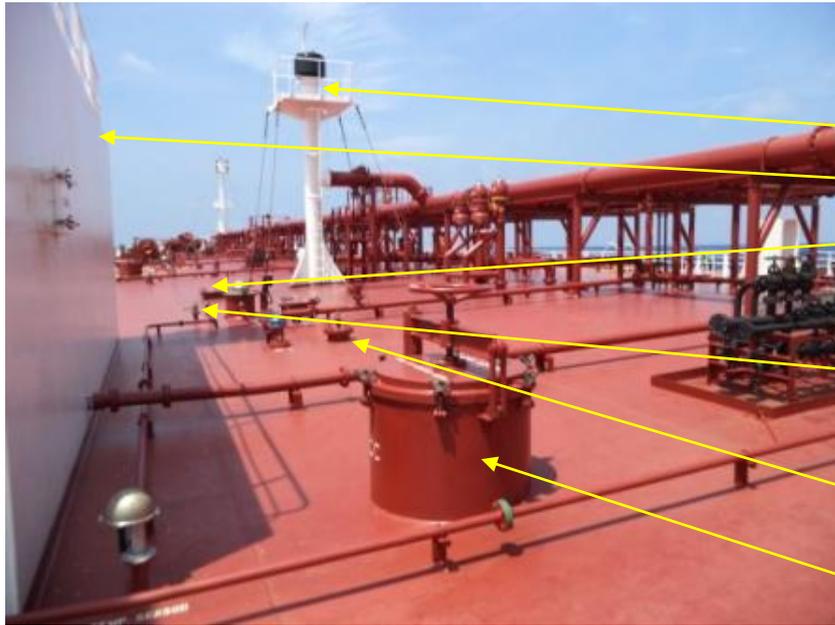
3 Port Cargo Oil Tank main deck area

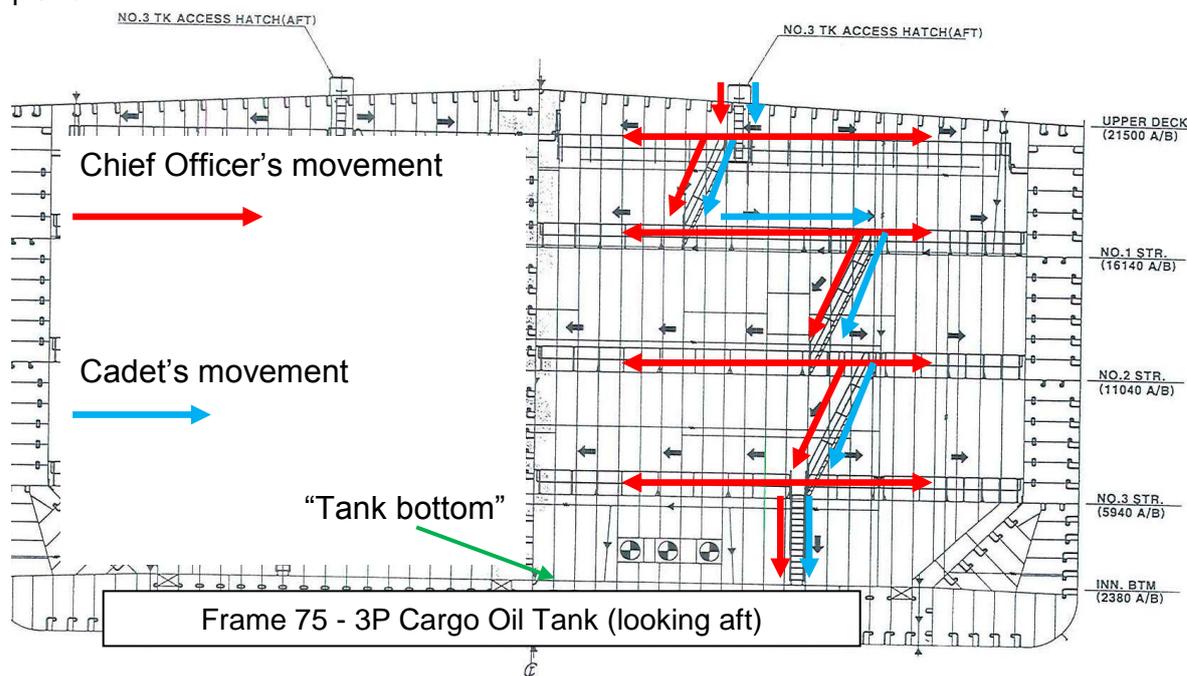
The diagram below depicts the movement of the Chief Officer and Cadet in 3P Cargo Oil Tank. The Chief Officer proceeds first, he climbs down onto the first platform and checks the atmosphere across the platform with the personal gas meter. The Cadet then proceeds down the stairs to meet him. This is repeated for the remaining platforms until No 3 Str platform.

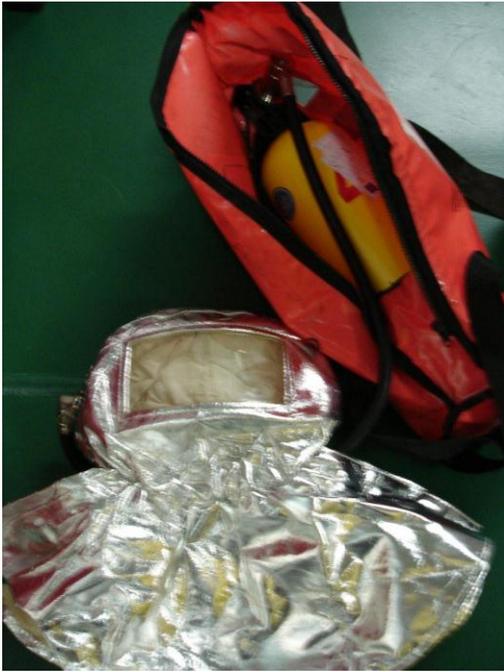
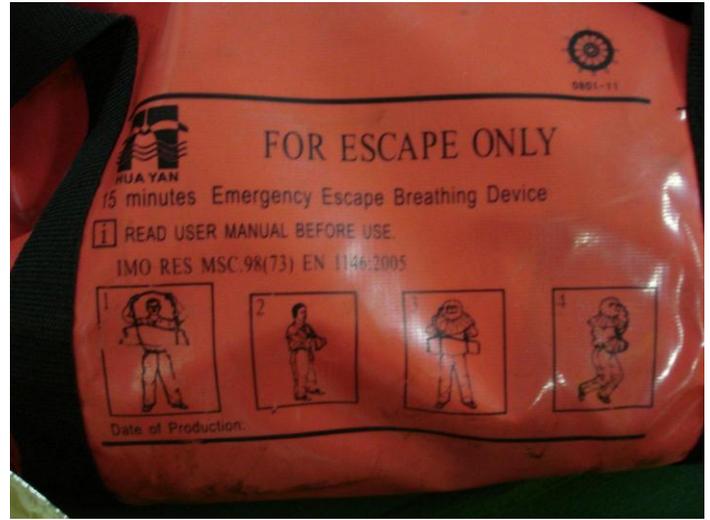
The Sharp Lady is provided with 15 Jiangsu Huayan Marine Equipment EEBDs each capable of approximately 15 minutes duration of average usage. The EEBD is approved to IMO Res MSC.98(73). The EEBD is a self-contained, open circuit, compressed air, constant flow EEBD. It comprises a compressed air cylinder with a combined reducer/cylinder valve, attached to a close fitting escape hood by a breathing hose. The whole unit is contained within a stowage bag ready for immediate use. The high-visibility bag is clearly marked FOR *ESCAPE ONLY*. See the following pictures;

The manufacturer's instructions state EEBDs are intended for use in atmospheres polluted by smoke, toxic gas, hot vapour or low oxygen levels while escaping to a place of safety. The 15 minute duration of the EEBD is achieved by means of a reducer/cylinder valve which restricts the flow of air from the cylinder to the mask, so that once activated a steady flow of air is provided to the wearer. It is not a demand valve system. It is likely that as the Cadet lay unconscious on the tank bottom the constant flow of air from the EEBD reduced the damaging effects from the toxic gas.

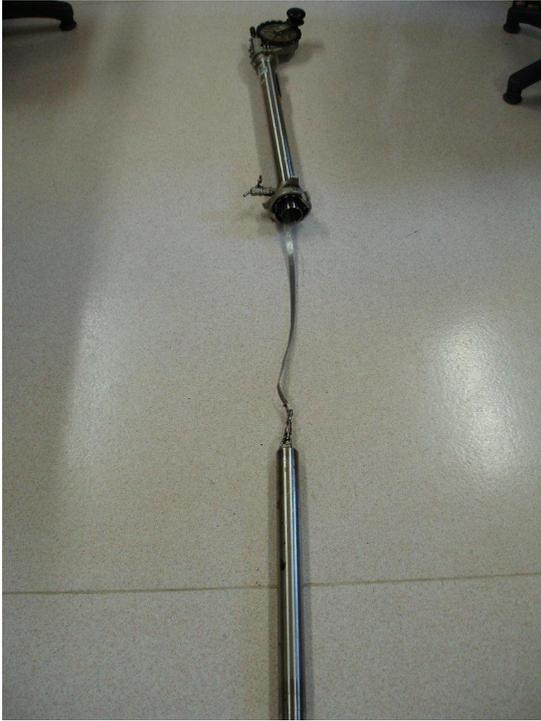
The complete oil sampler device

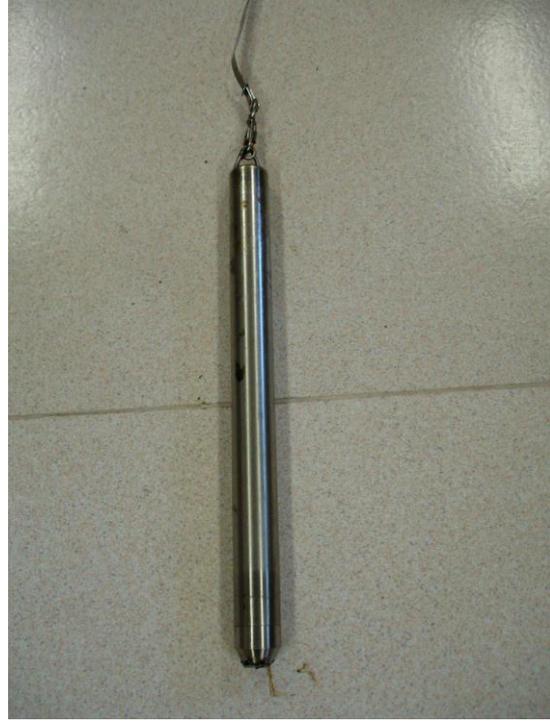
The oil sampler bucket

Note – this is not the oil sampler that broke in Geelong on the 09th August 2013.
