# National Transportation Safety Board

## Marine Accident Brief

### Grounding of Mobile Offshore Drilling Unit *Kulluk*

<b>Accident no.</b>	DCA13NM012
<b>Accident type</b>	Grounding
<b>Vessel</b>	Mobile offshore drilling unit <i>Kulluk</i>
<b>Location</b>	Near Ocean Bay, Sitkalidak Island, Alaska
<b>Date, time</b>	December 31, 2012 2040 Alaska standard time (coordinated universal time – 9 hours)
<b>Damage</b>	Substantial
<b>Injuries</b>	Four minor
<b>Environmental damage</b>	None
<b>Weather and sea conditions</b>	At departure, moderate winds and seas with scattered precipitation, expected to continue during first days of voyage; several days later, low pressure moved into Gulf of Alaska area. By December 31, recorded winds reached 40–55 knots, with seas more than 20 feet.
<b>Waterway information</b>	Gulf of Alaska lies south of the state of Alaska in the northern Pacific Ocean

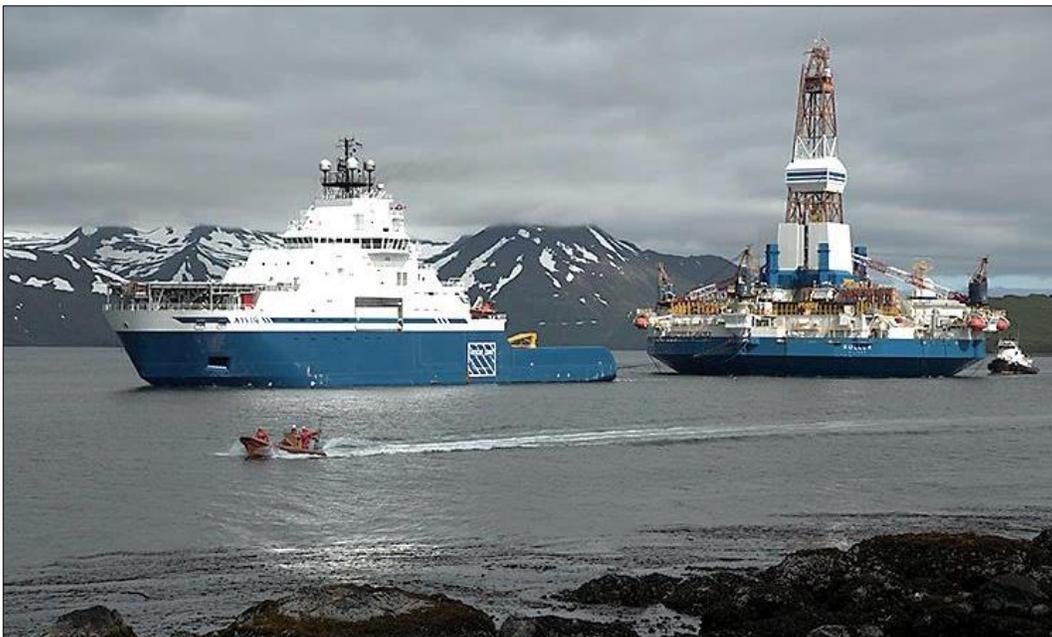
Tow vessel *Aiviq*, left, tows Shell's conical drilling rig *Kulluk* before the *Kulluk* grounding in December 2012. (Photo from [www.pbase.com](http://www.pbase.com))

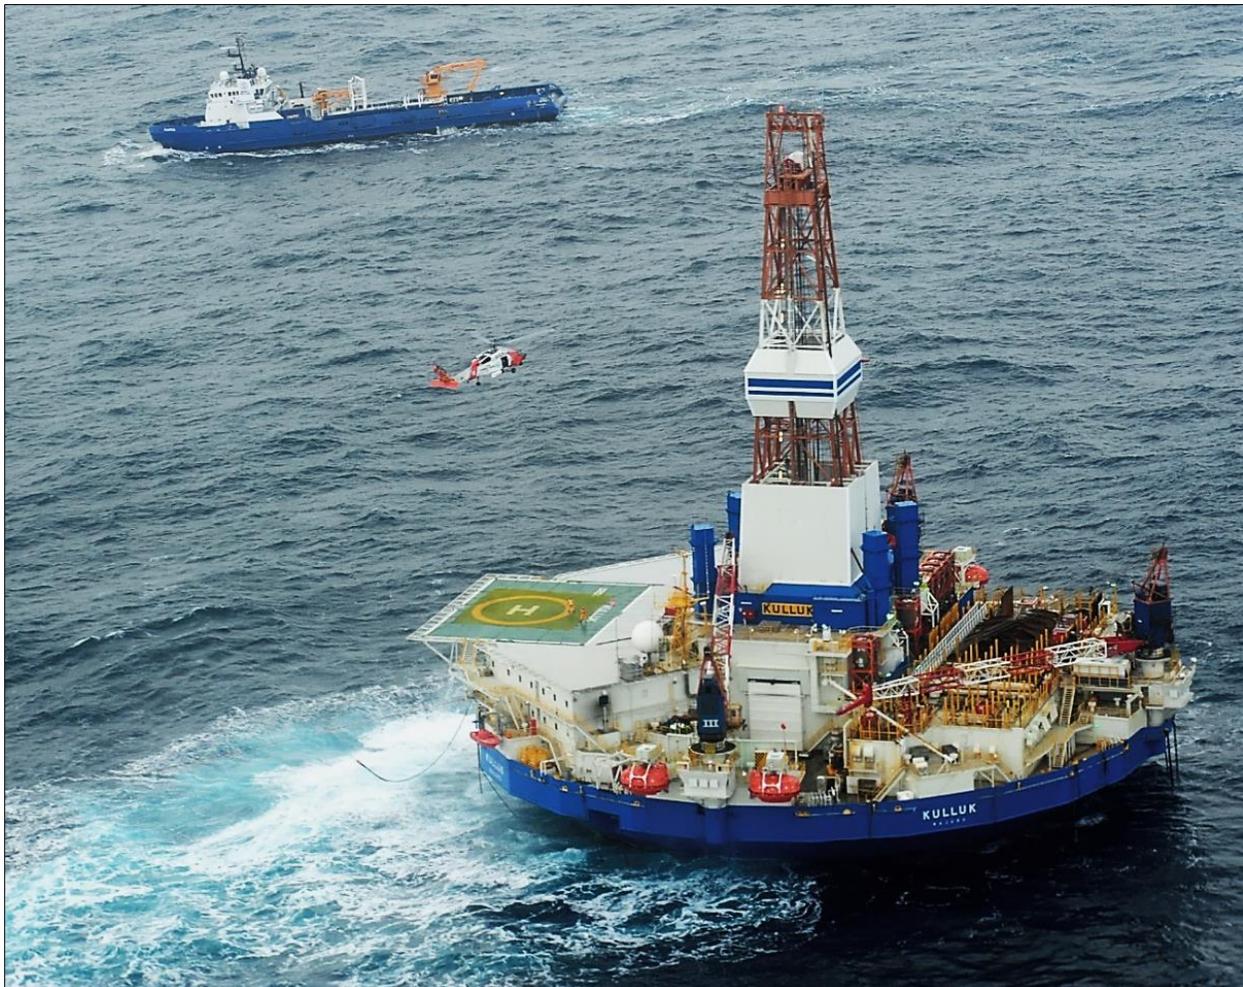
Coast Guard MH-60 Jayhawk helicopters from Air Station Kodiak airlifted 18 crewmembers from the *Kulluk* on December 29. The oil spill response vessel *Nanuq* is in the background. (Photo by Coast Guard)
